SERVICE BULLETIN

SEGA Bass Fishing™ ALL CABINET STYLES

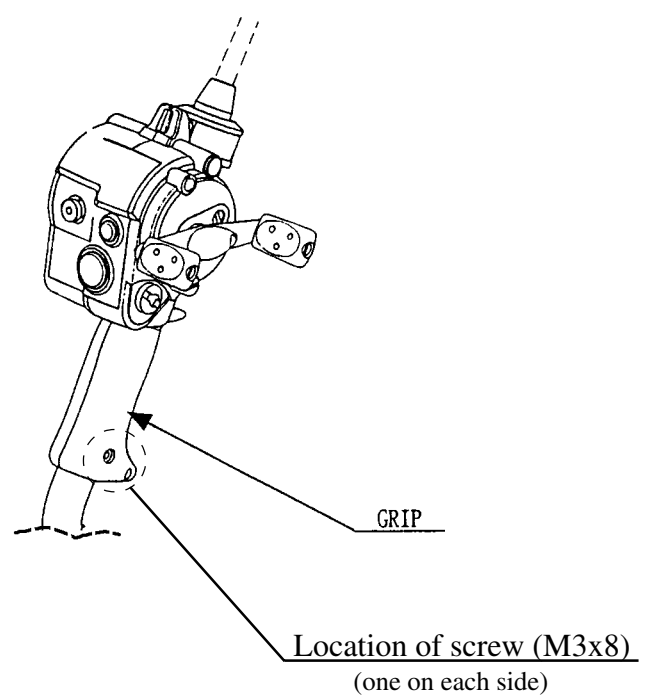
PROBLEM: Torq and wear applied to Bass Fishing handle causes an M3x8 screw (located near the 'butt' end of handle) to work it's way loose.

NOTE: Do not replace with longer screw, as this can pierce the wire harness located within the handle assy, causing a short circuit and/or failure.

SOLUTION: Apply a small amount of blue loctite to screw before reinserting it.

USE BLUE LOCTITE
PART NO. 242
