SERVICE BULLETIN

SEGA BASS FISHING UPRIGHT

PROBLEM: The Handle for BASS Fishing's Upright Cabinet is breaking due to abusive load/torq applied to the Handle Assy.

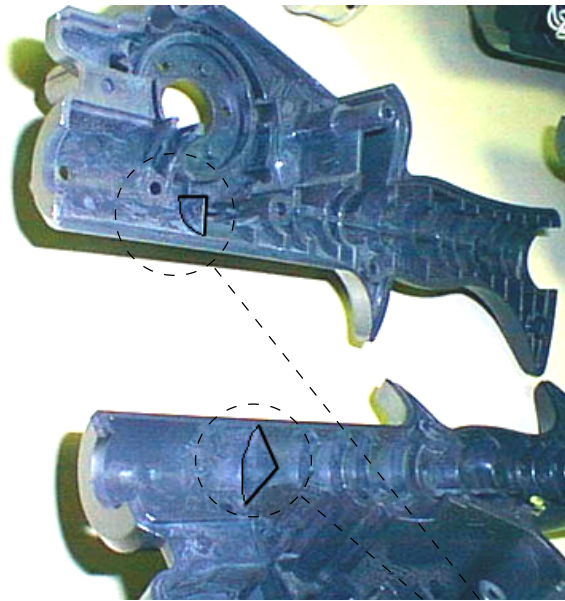
View of the inner portion of the Handle Assy housing. Shown with and without the ribbed portion cut away to allow room for the reinforced metal tip.

- 5 Next cut away a ribbed portion of the Handle Assy as shown in photos ABOVE to allow enough room for the new piece to be installed.
- 6 Replace the black Rod Tip with the reinforced metal Rod Tip.
