MODIFICATION INSTRUCTIONS

EFFECT: X-Y TIMING BOARD

NUMBER: 007

September 17, 1981

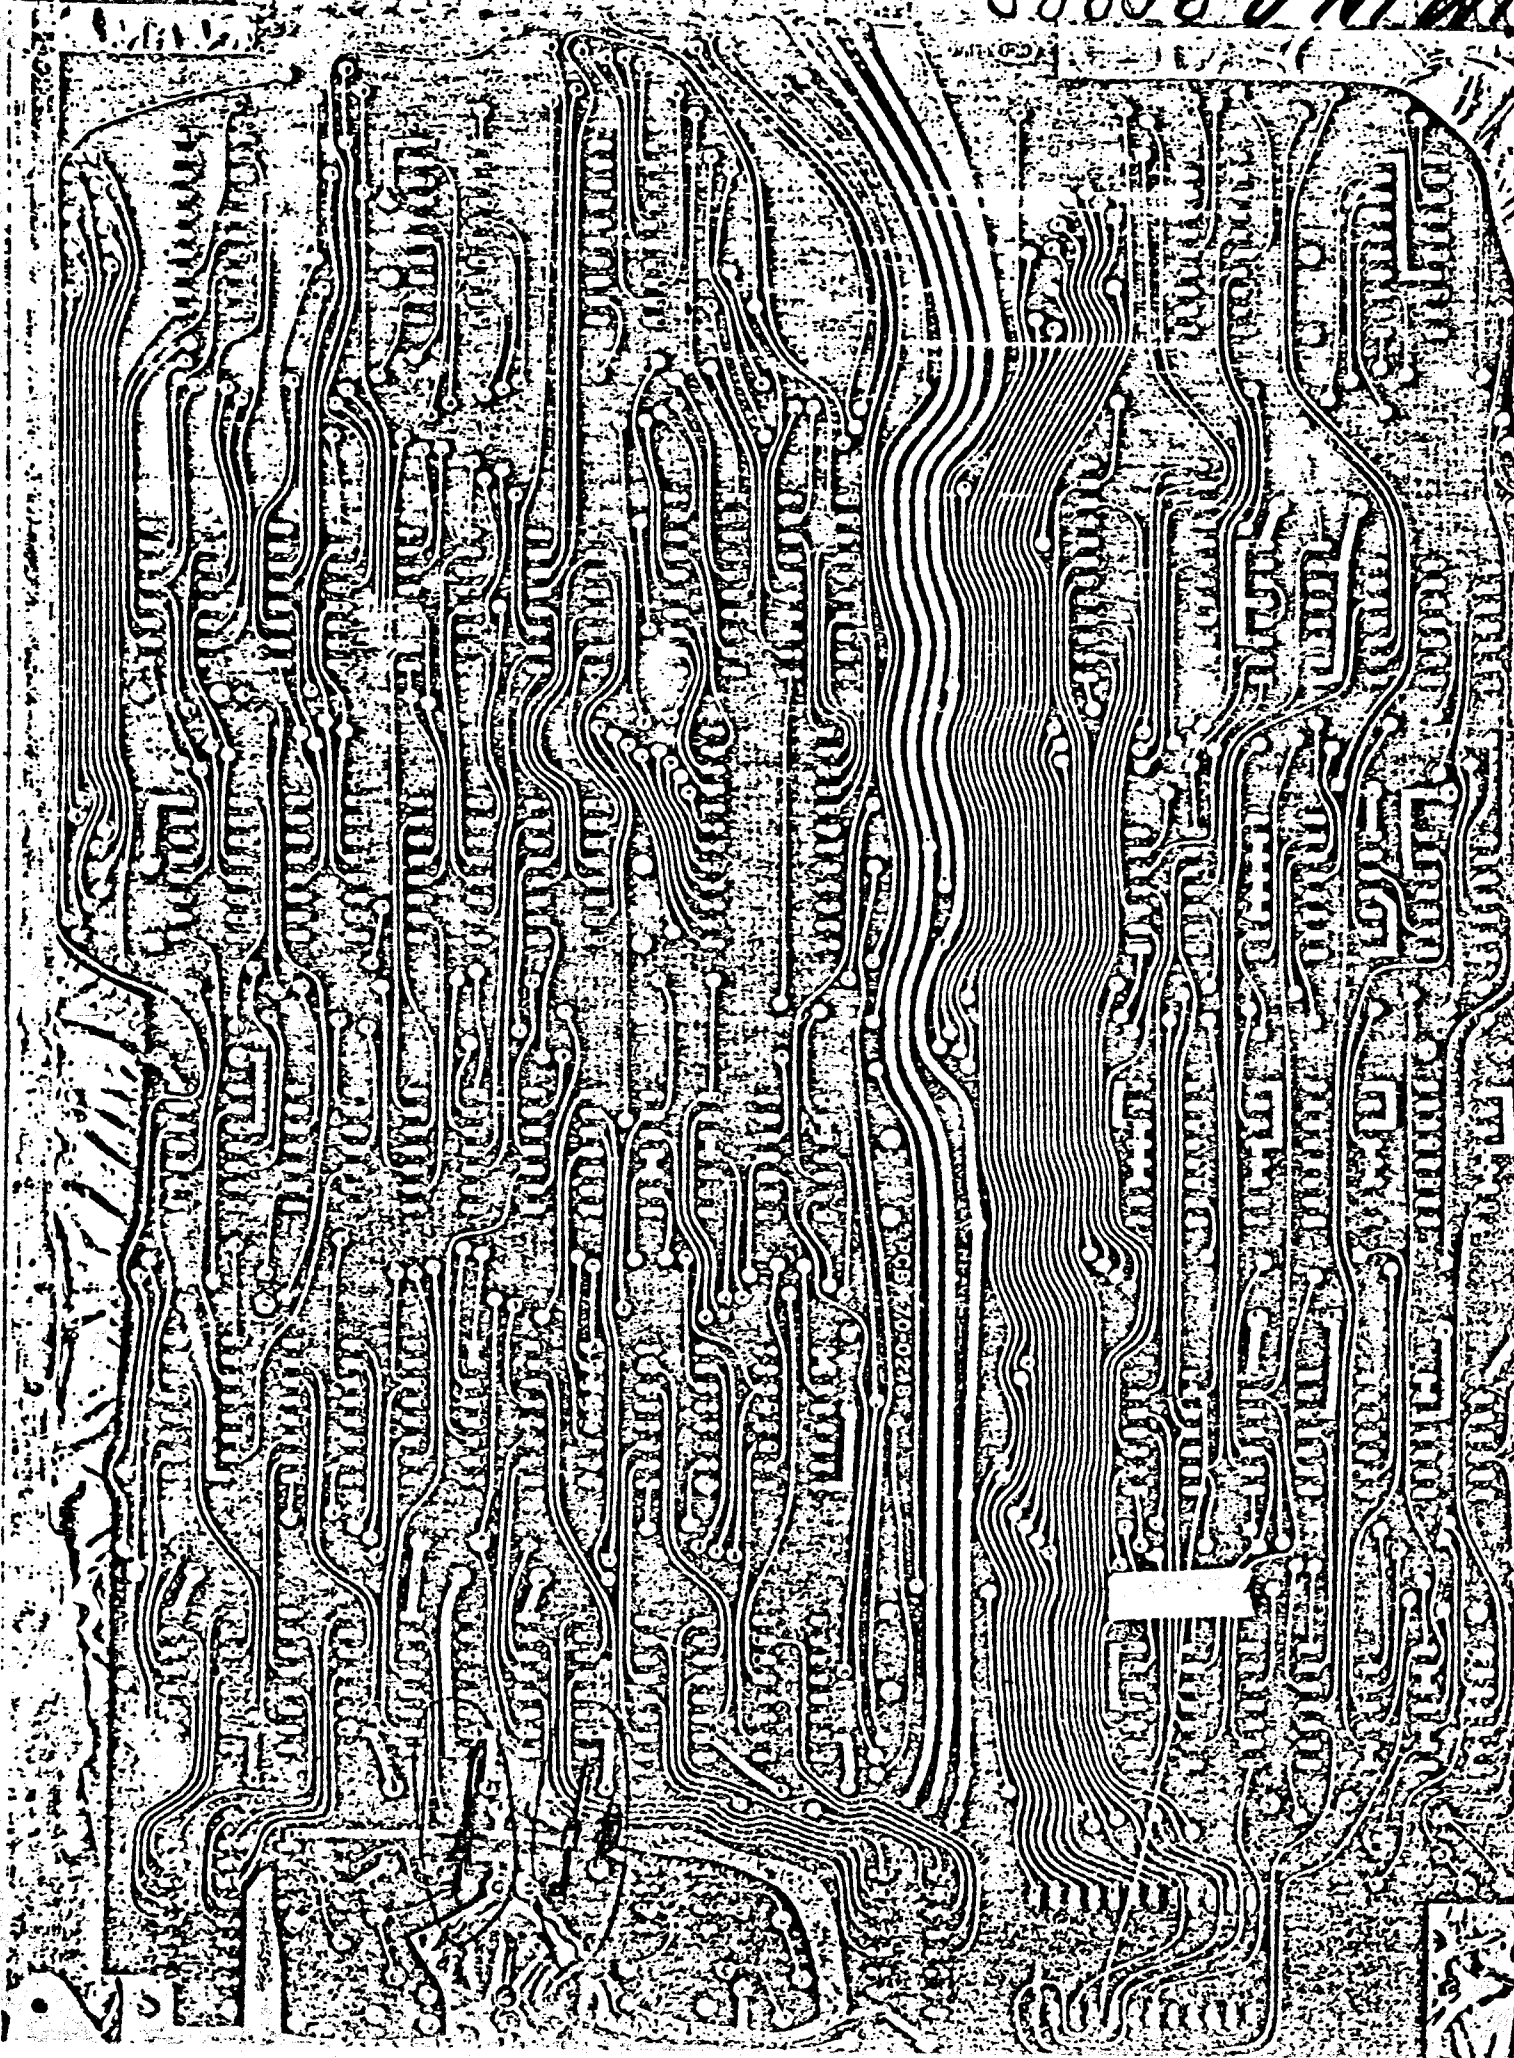
PCB 70-01288

Q5 →
C45 →

P/N 151-0031 QTY (1) CAP CER .22UF 16V C45

REDUCE POWER ON DELAY FROM 1.5 SECS TO 20 MSECS TO ALLOW XV MONITOR OUTPUTS TO BE RESET IN 20 MSECS THEREBY REDUCING STRESS ON MONITOR OUTPUT CIRCUITS
